March 2006 Shutdown Week 5

“Violating the second law of thermodynamics”

R.J. Tesarek

Fermilab

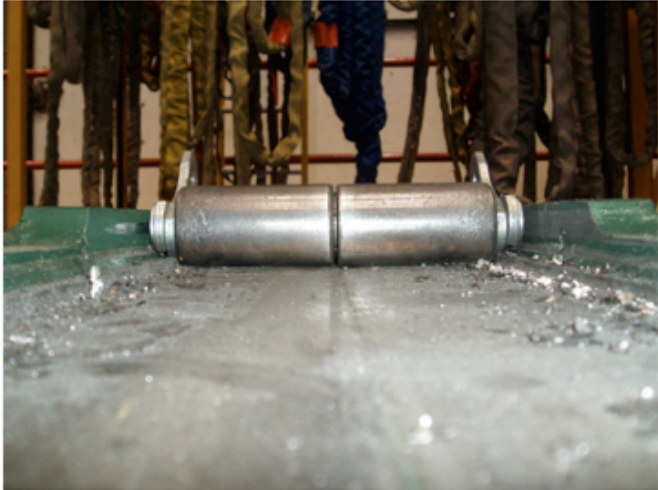
Damaged Hillman roller and bearing surface. The Hillman roller is upside down in the figure. The load bearing plate at the bottom. Note the flaking metal at the edges of the bearing plate and the discoloration of the rollers near the edges.

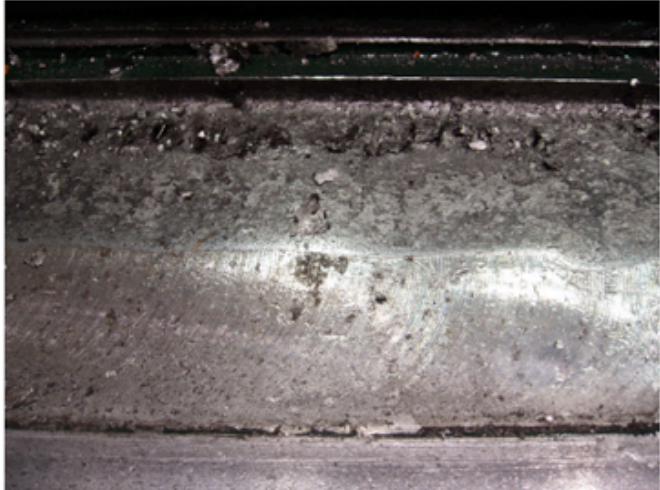
Bearing plate detail. Note the milling marks from manufacture of the bearing surface near the center. The edges show the flaking metal off of the bearing surface (only one side shown).

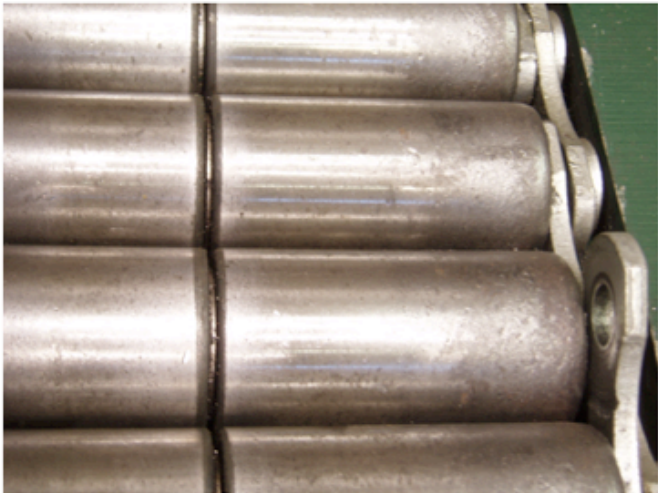
Damaged Hillman rollers. Note the discoloration of the edge of the bearings. Pitting is observed over the whole roller surface, but the edges are particularly damaged.

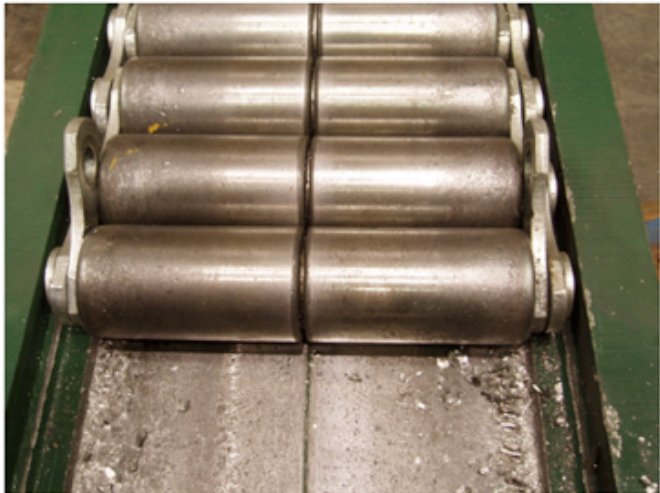
Hillman rollers and bearing surface.
